Phase I Inspection Report  
 Batavia Kill Watershed Project Dam No. 4A  
 Mohawk River Basin, Greene County, New York  
 Inventory No. N.Y. 570

Phase I Inspection Report  
 National Dam Safety Program

**DAM NO. 4A  
GREENE COUNTY, NEW YORK  
INVENTORY NO. NY 570  
PHASE I INSPECTION REPORT  
NATIONAL DAM SAFETY PROGRAM**

**Date of Inspection:** November 21, 1978

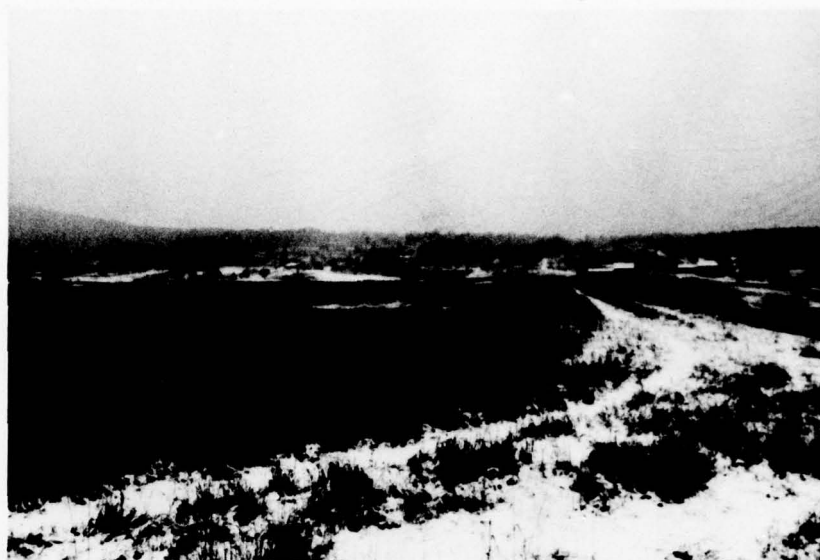
Upstream Face of Dam-Looking East

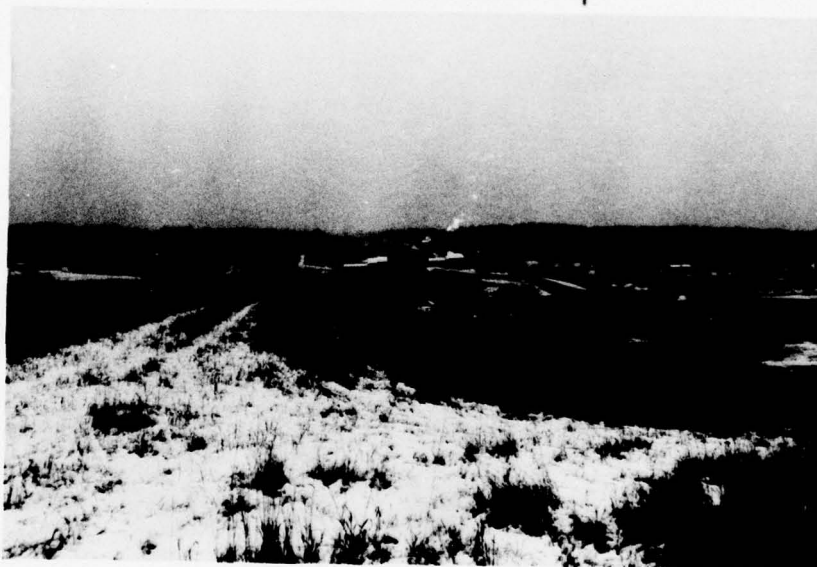
The earth embankment showed no signs of distress. The vertical and horizontal alignment of the crest appears to be as it was constructed with no visible surface cracks appearing on the crest or embankment slopes. There were no areas of sloughing or subsidence noted.

Inspection of the downstream face did not reveal any signs of seepage. At the time of the inspection, there was no discharge from the collection pipes of the internal drainage system. No undesirable vegetative growth or animal penetrations into the slopes were observed.

Downstream Face of Dam-Looking East

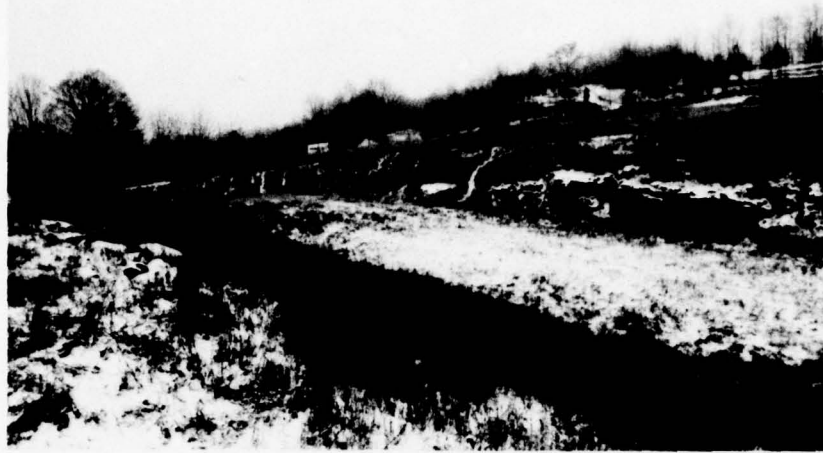
The two emergency spillways were in satisfactory condition. One spillway is in a rock cut, but has a grassed bottom. The other spillway is in an earth cut.

West Emergency Spillway-Rock Cut-Looking Downstream

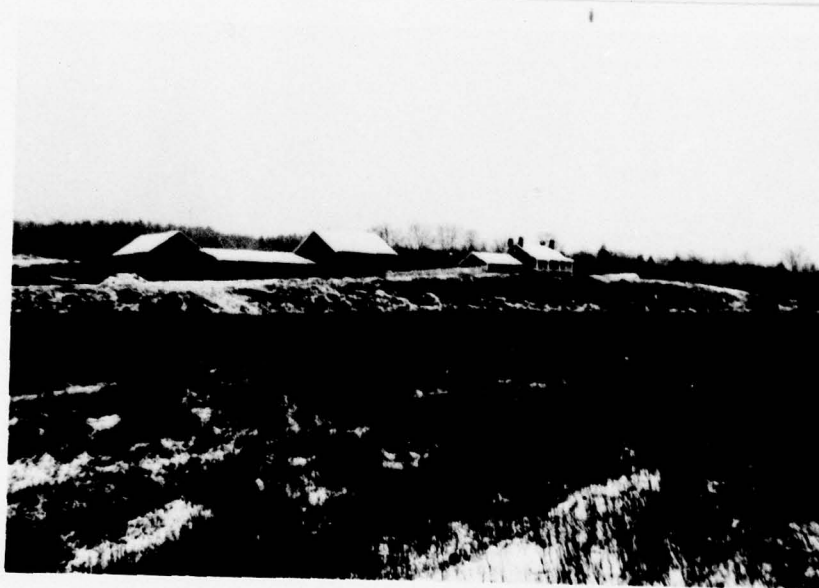
East Emergency Spillway-Looking Downstream

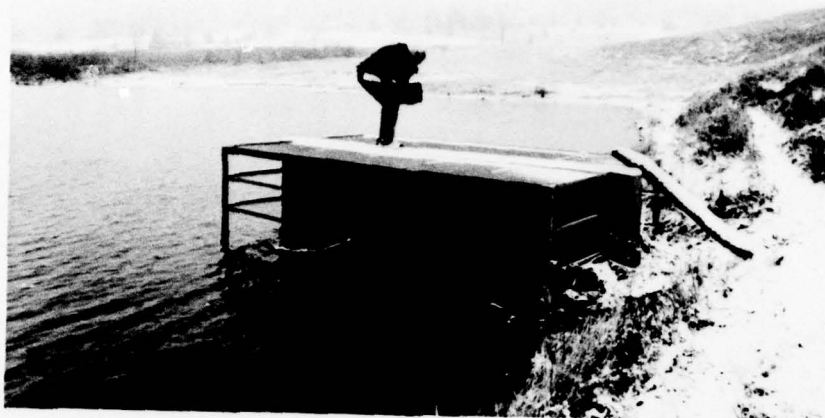
The principal spillway pipe, the riser and the plunge pool were all in satisfactory condition.

Principal Spillway Inlet-Riser

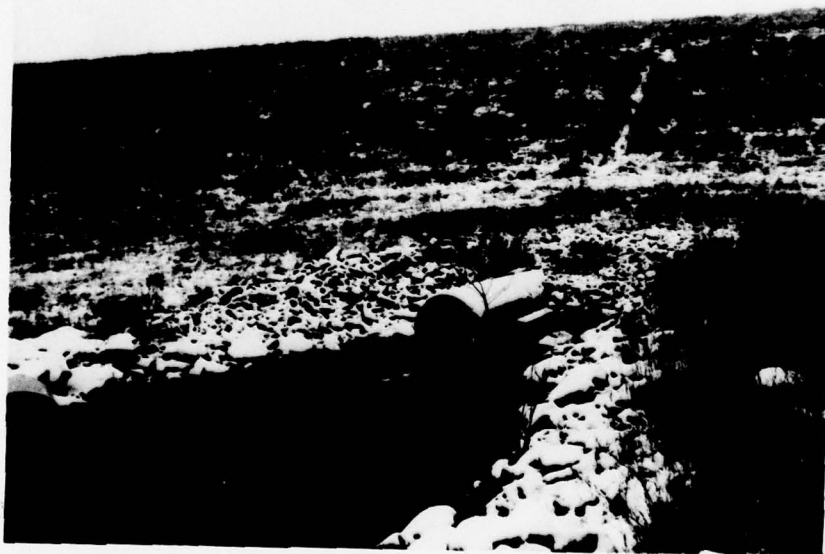
Principal Spillway Outlet Pipe and Plunge Pool  
Looking Upstream

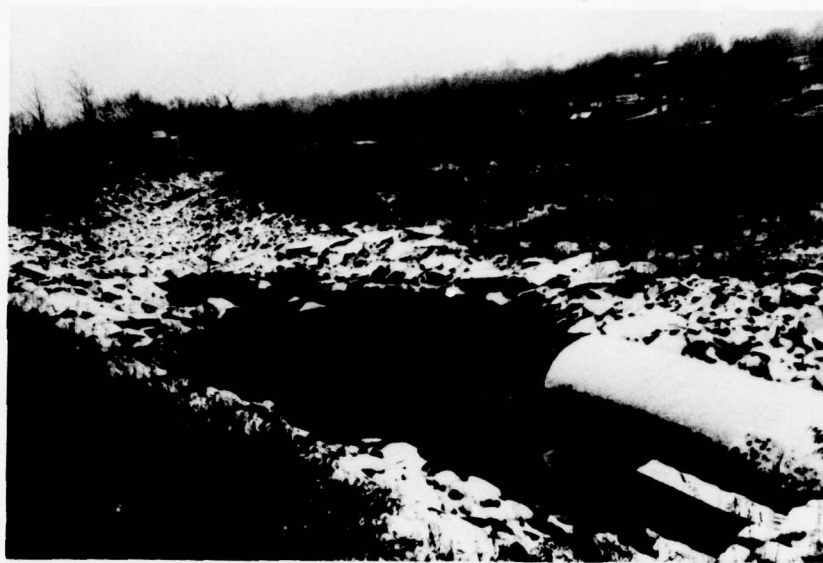
The outlet channel was in satisfactory condition, with no severe side slope erosion or debris obstructions in evidence. The section of channel nearest the plunge pool had been overexcavated and backfilled with rock. During periods of low flow in the channel, this results in the water disappearing in this section and re-appearing further downstream.

Principal Spillway Outlet Pipe and Plunge  
Pool Looking Downstream
